# Manhole Inspection Summary

Manhole # S35MM\_033MH

Insp Date: **3/6/07 12:05 PM**

**Location** Address: **100 22ND ST**

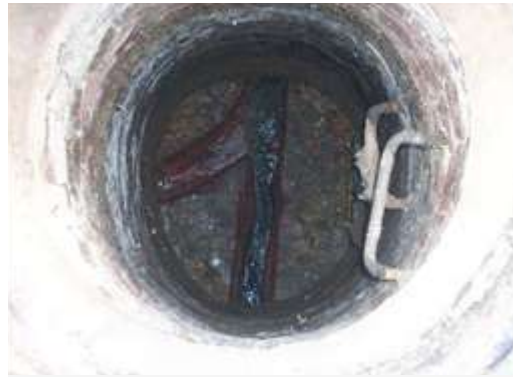
Top View

Corroded steps. Evidence of surcharge - Bench debris.

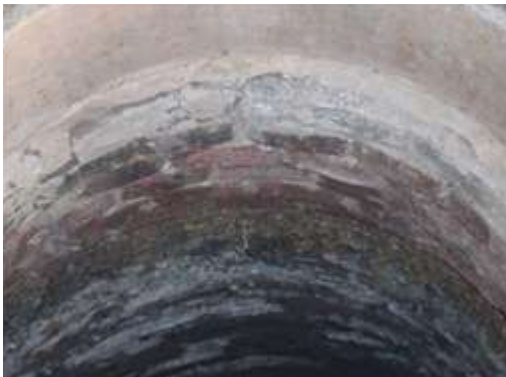
Defect

Frame leaks. Adjustment deterioration and infiltration. Barrel infiltration.

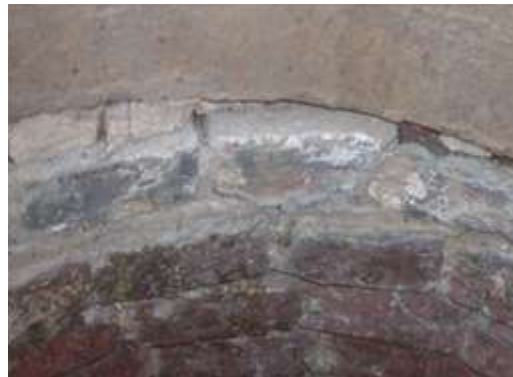
Defect

Frame leaks. Adjustment deterioration and infiltration.

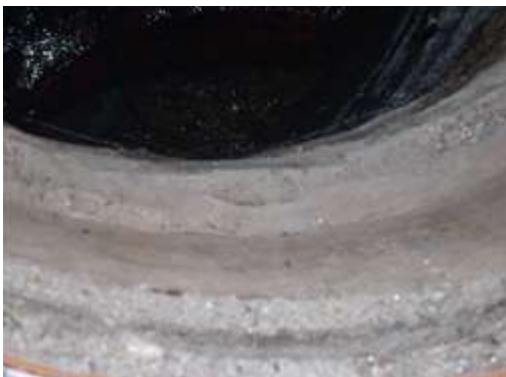
Defect

Frame leaks. Frame offset.

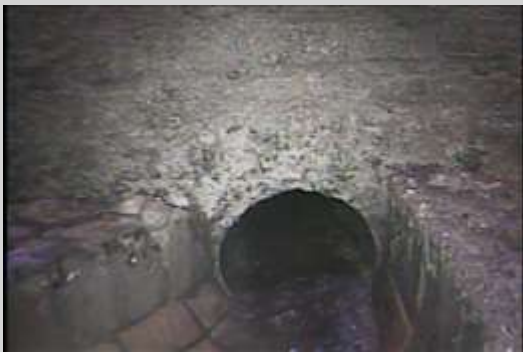
### 8 in. Circular Gravity Sewer Pipe Out @ 12 O'Clock

Deposits: ☐ None ☐ Mud ☐ Sludge ☐ Debris ☒ Grease

Silt Depth: **0** (in.) Deposits Extent: **Light**
